TITLE: SprayVision: 2020's "Best New Idea" Opens the Window to Improved Aerospace Finishes

INTRODUCTION

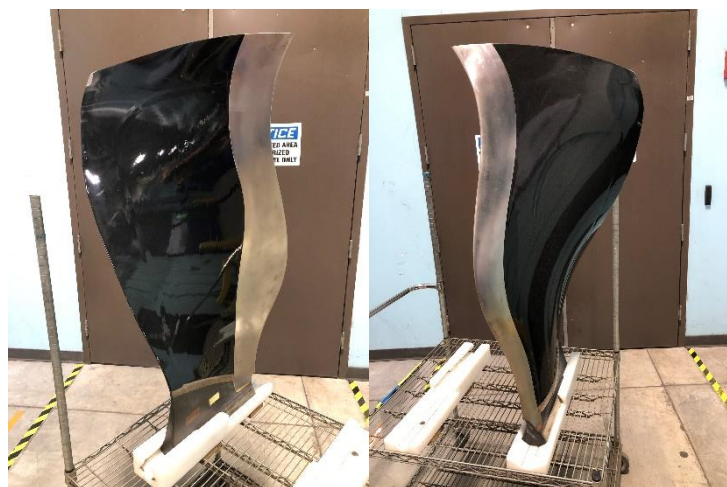
Figure 1: CFAN Jet Engine Turbine Blade

Turbine fan blades create thrust by extracting energy from the high pressure and temperature generated by the jet engine's combustor. Shown in Figure 1, the fan blade exhibits a uniquely complex geometry from the convex to concave

side of the component. As you might imagine, this application exerts extreme forces on the blade surfaces, so each blade is constructed of a combination of titanium and composites to provide the required strength. CFAN builds fan blades in strict accordance with the Engineering and Quality specifications derived directly from GE Aviation. Exterior paint is no exception. It poses a significant challenge to bond to these different surfaces while maintaining consistent cured-coating characteristics from side-to-side. Moreover, the coating must be capable of withstanding a battery of severe tests, including ASTM D 4541 adhesion testing and rain erosion. This all starts with the primer, making it the logical starting point for this exercise.

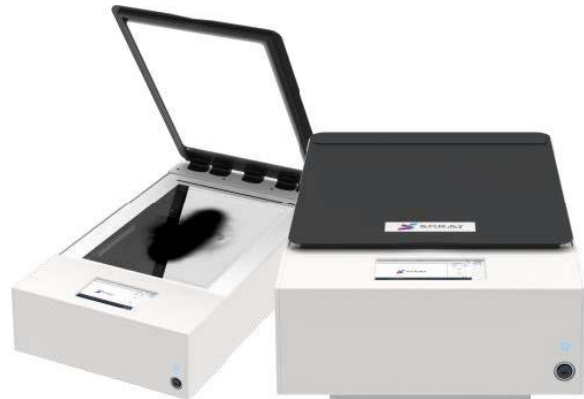
Figure 2: SprayCapture A3 Unit

The primary reason this investigation was scheduled in the first place, is the SprayVision system, which is built around the SprayCapture Unit shown in Figure 2. It is available in two sizes. The larger A2 system (not shown) is commonly used for bell applications, and the smaller A3 system (shown) is more commonly used for gun spray applications. One of the most innovative features of this capturing technology is that it is designed to accept capture films while they are still wet, which allows for immediate analysis without waiting until after the curing process as is common in traditional paint quality systems.

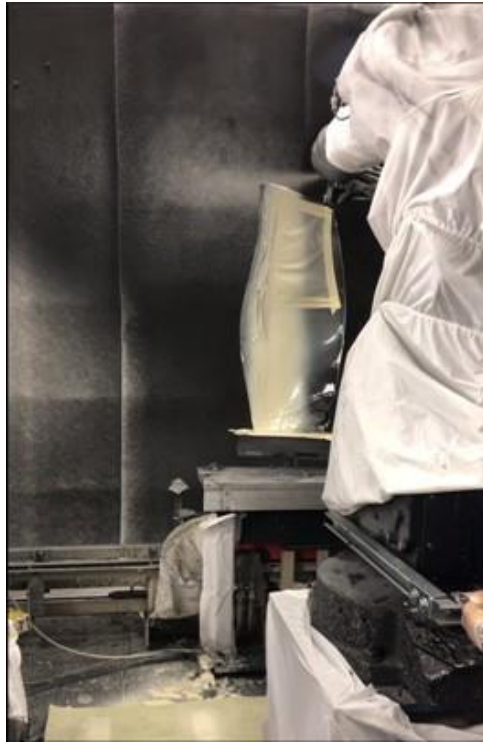
Figure 4: Conveyorized Robotic Paint Application

CFAN's automated paint system is a tightly controlled modern conveyorized paint line built around an ABB/IRB580 paint robot equipped with standard Iwata HVLP guns as shown in Figure 4. The mix room, shown in Figure 5, is

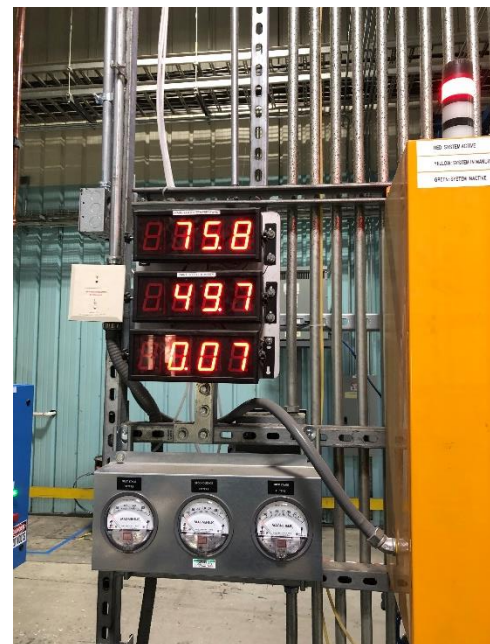
Figure 6: Booth Monitoring Stack Showing 75.8°F and 49.7% RH

The ambient environment in both the mix room and spray booth is tightly controlled by the same make-up air system to assure a consistent 75°F and 50% RH as shown by the Booth Monitoring Stack in Figure 6. Even the blades are thermally preconditioned to assure that they also enter the booth at 75°F as shown in the thermal scan in Figure 7.

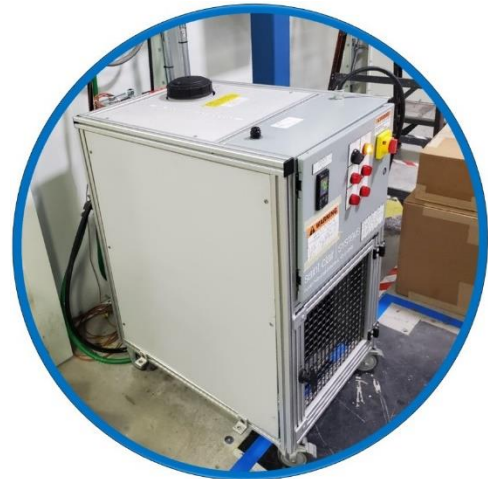
Figure 8: AT-5900 TCU

The temperature control system is comprised of the AT-5900S Heat/Cool Temperature Control Unit (TCU), shown in Figure 8. This performs the control functions to assure that the paint is dispensed at the desired temperature by circulating temperature conditioned thermal transfer fluid to and from the process. The actual thermal transfer function is performed by SCS' patented Recorable Coax Hose System, shown in Figure 9 in place on the CFAN robot. This is installed around the existing paint line, creating a path for the thermal transfer fluid and converting the paint line into a flexible heat exchanger.

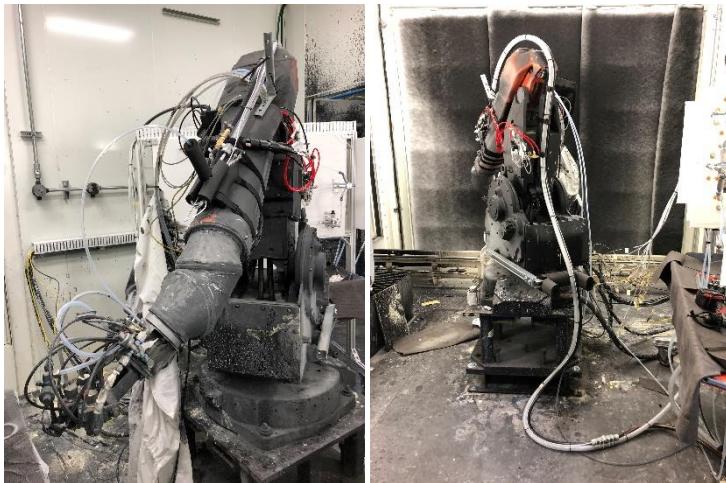
Figure 9: Recorable Coax System in Place on Robot

pressure drop to the system and therefore no significant changes must be made to the system or system settings to implement temperature control.

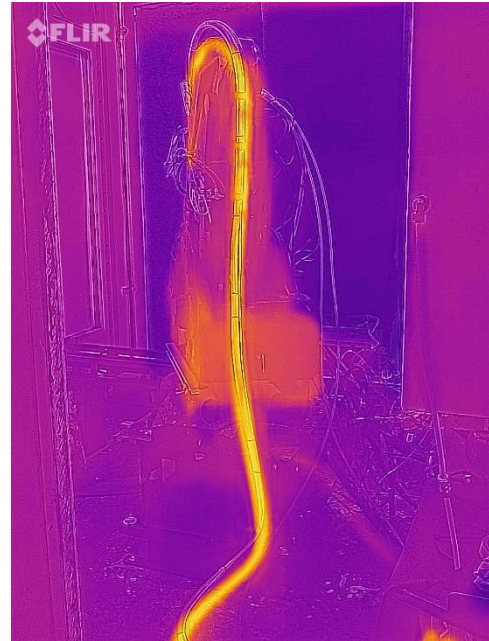
Figure 10: Thermal Scan Showing Control to Point of Dispense

Placing the temperature sensor on the robot arm just before the gun whip line extends temperature control to the point-of-application, as shown in the thermal scan in Figure 10, and compensates for any exotherm produced by the 2K mix. Because it uses the original paint line, it adds no volume or

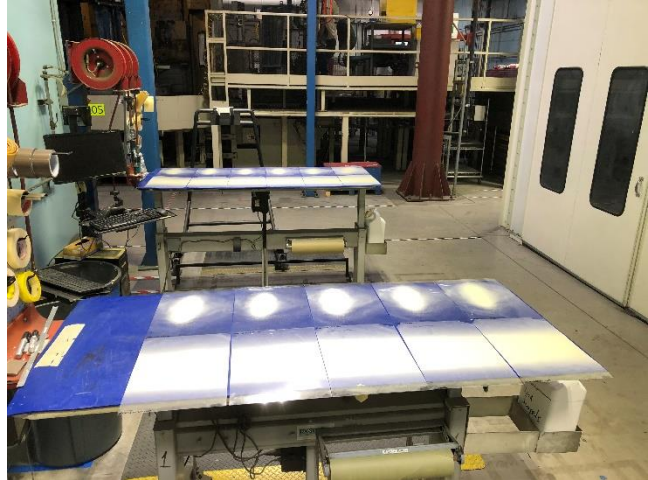
Figure 12: Set of 11 Static and 11 Dynamic Films to Analyze Viscosity Impact on Painting Process

This procedure was repeated for temperatures from 70°F – 120°F in 5°F increments. The result was the set of 22 films (11 static and 11 dynamic) shown in Figure 12, each sprayed with the same coating, program, and settings. The only difference was the temperature-based viscosity variation in the primer itself.

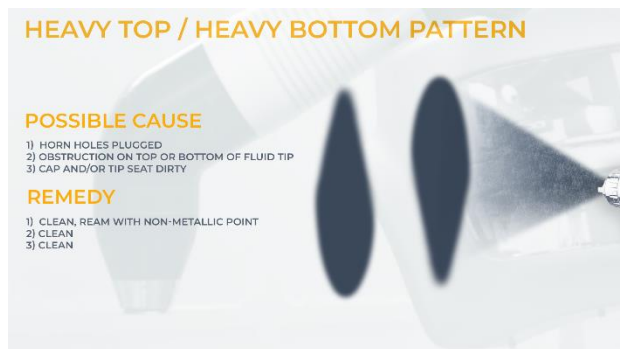
Figure 18: SprayVision Troubleshooting Guide for Pattern Distribution

As noted, paint distribution through the pattern is another important factor to consider. In both patterns in Figure 16, the distribution of paint is greater toward the top of the pattern. Though harder to distinguish in the 70°F pattern, in the 110°F pattern this is quite evident. Turning to SprayVision's troubleshooting guide, shown in Figure 18, this may be as simple as correcting the gun alignment so it is perpendicular to the surface, or it can be yet another symptom of an imbalance between

atomization and shaping air. This can be caused by an incorrect adjustment, or by an occlusion in one or more of the air lines or passages.
